## Blown Away

By Dave Helland

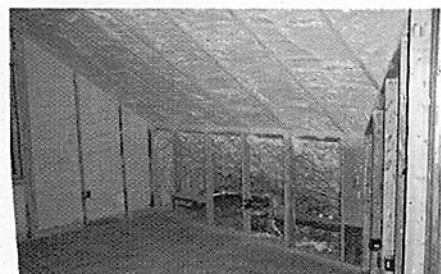
Icynene can reduce heating and cooling costs by 30-50 percent.

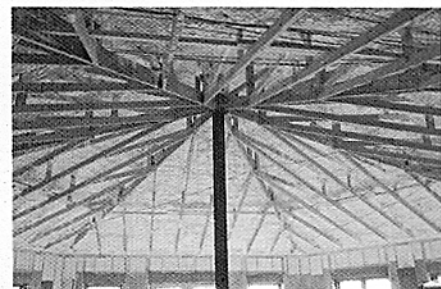
Spraying the product onto the underside of roof sheathing can prevent ice damming.

Next, I visited a house with an identical roof system (2-inch-by-12-inch rafters) that had been insulated with 8 inches of Icynene. The foam was applied to the underside of the roof sheeting with no ventilation. There was absolutely no ice damming on this home all winter long. Instead, the sun eventually warmed and melted the snow from the top down rather than the heat escaping from the house melting the underside.

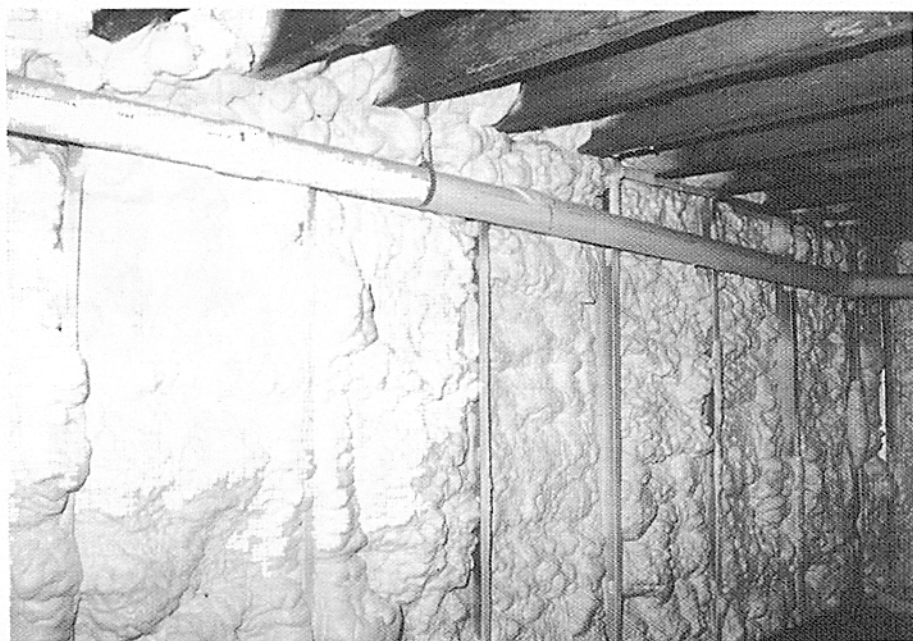
In crawl spaces, garage ceilings and cathedral ceilings, the product forms an air barrier preventing heat, air and humidity from passing through the walls.
